Inspection Report
Minerals Regulatory Program
Date: March 15, 2009

Mine Name: Island Rock 1	Permit Number: S/045/0066
Operator Name: John Bleazard	Inspection Date: 10-29-2008
Inspector(s): L. Heppler	Time: 5:00 PM
Other Participants: none	Mine Status: ACT

Purpose of Inspection: Routine annual inspection

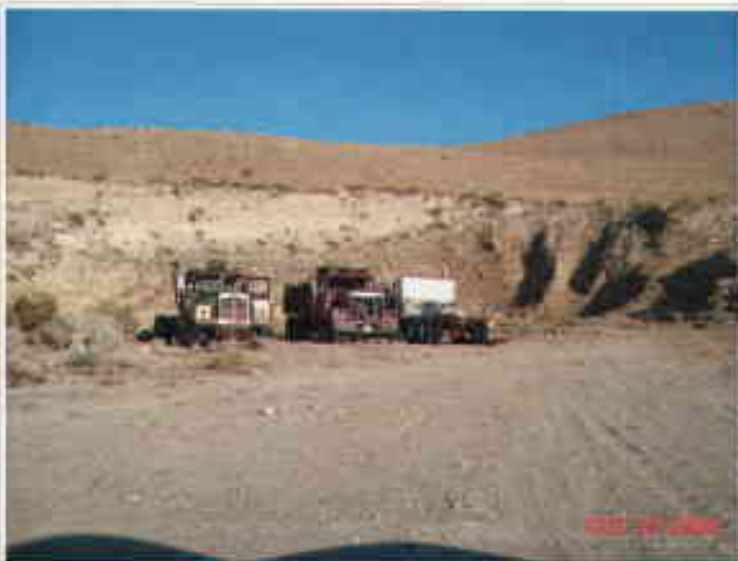
Abandoned Trucks

Conclusions and Recommendations: Equipment needs to be salvaged. Bond needs to be escalated. OGM to continue annual inspections and monitor the site when in the area.

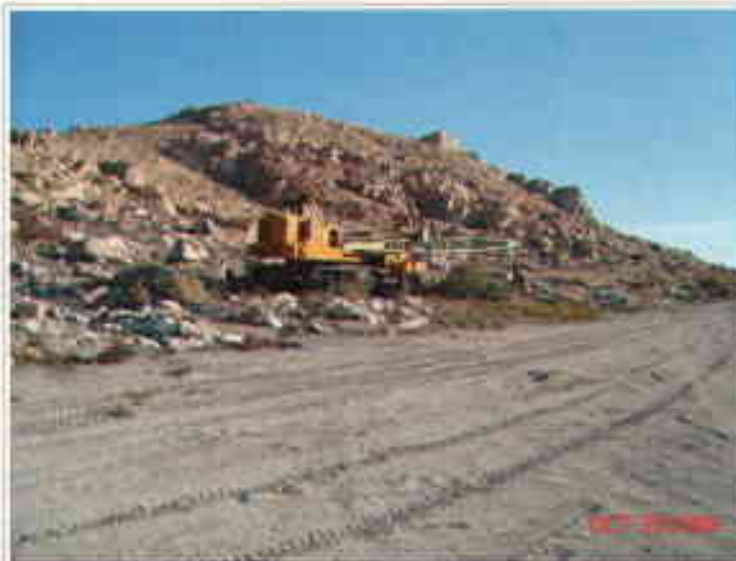
Abandoned Dragline

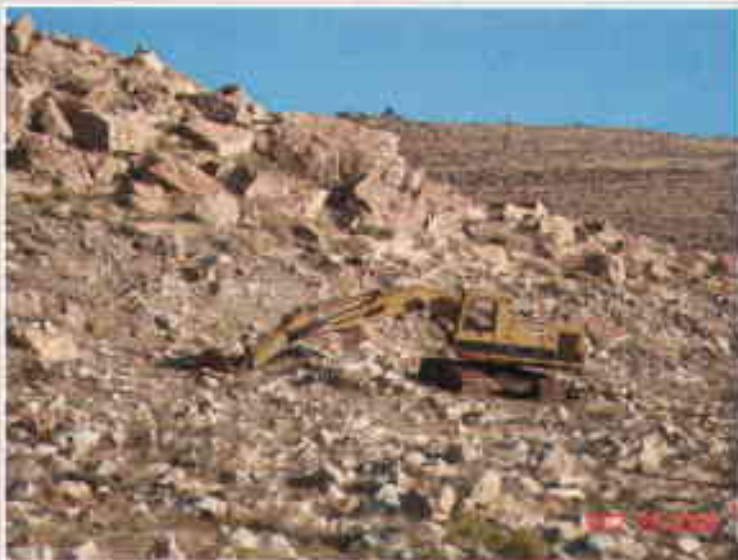
Abandoned trackhoe

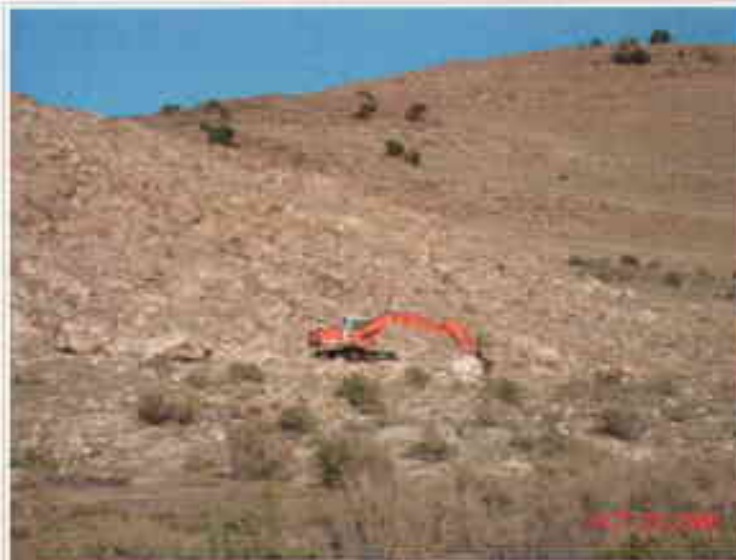
Abandoned trackhoe
